22. Site 22 at RM 436.4 LDB (Pool 18)

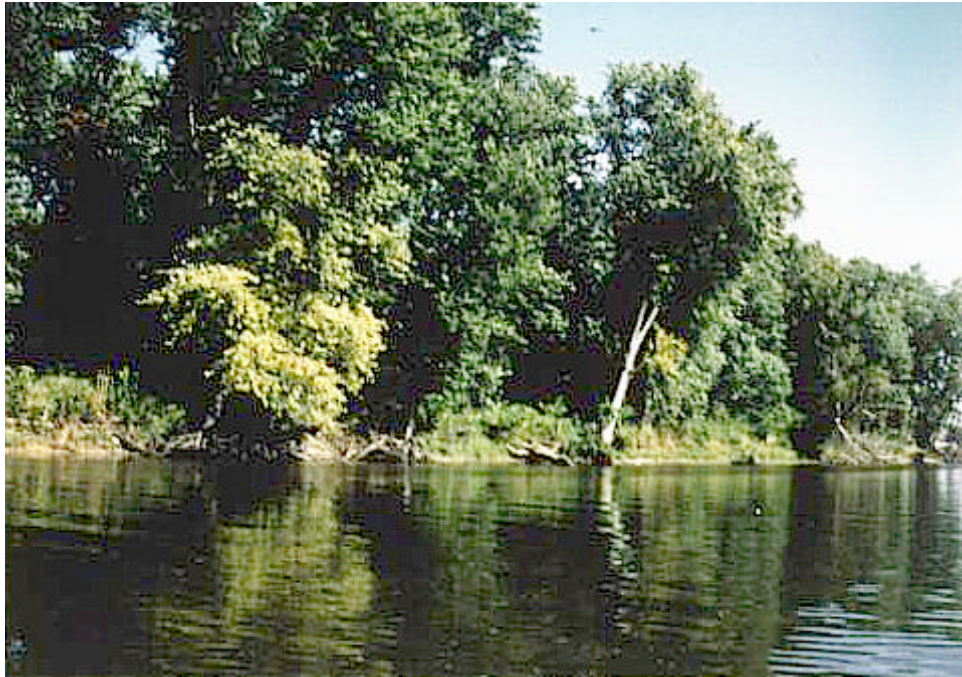
Photo 7-53 A side view of Site 21 midpoint

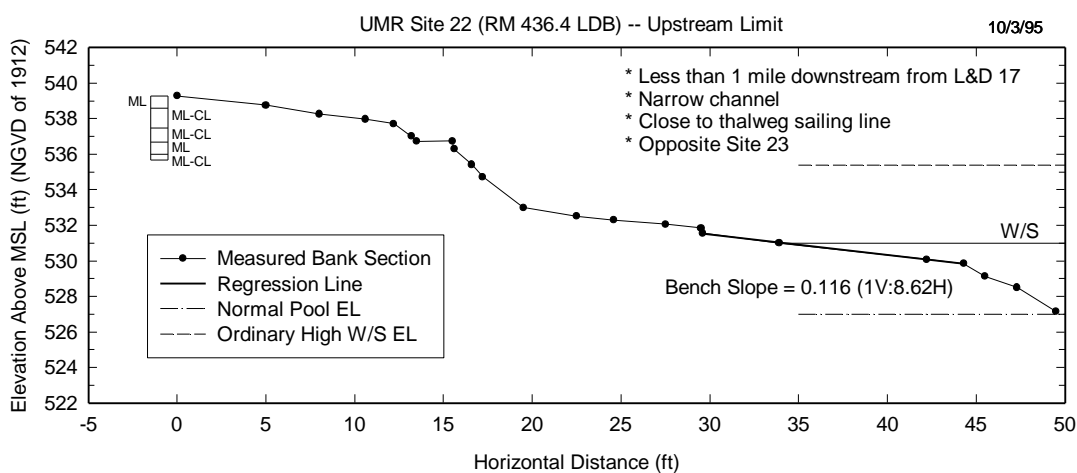
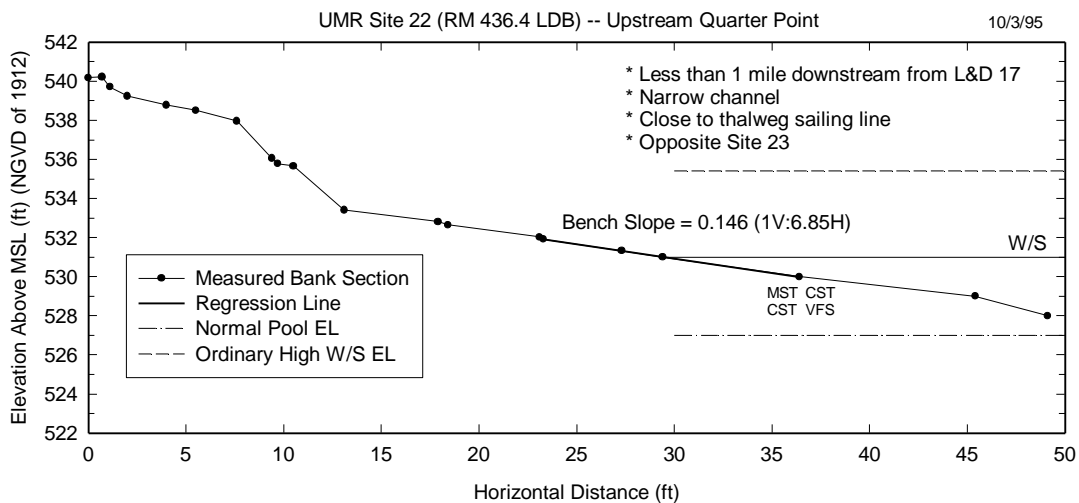
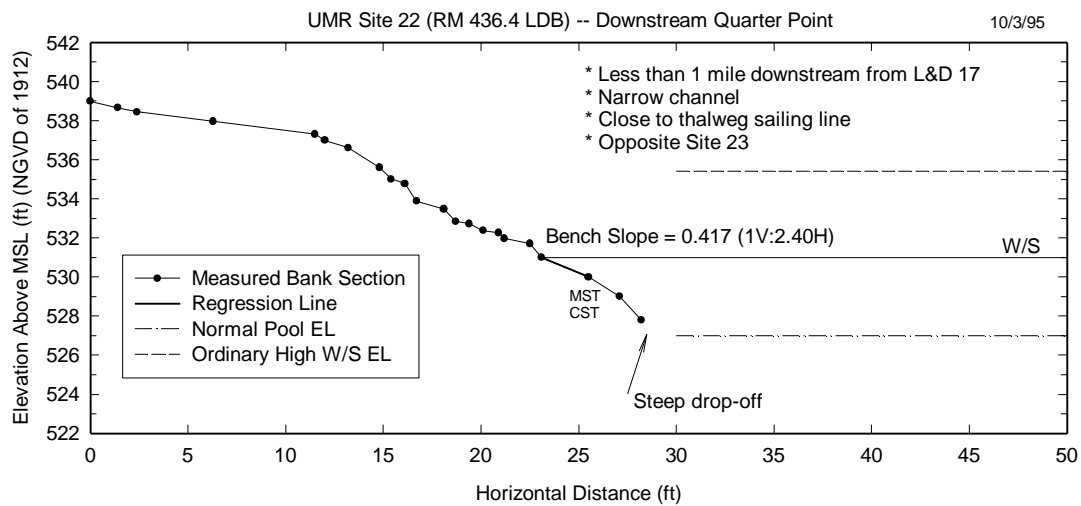
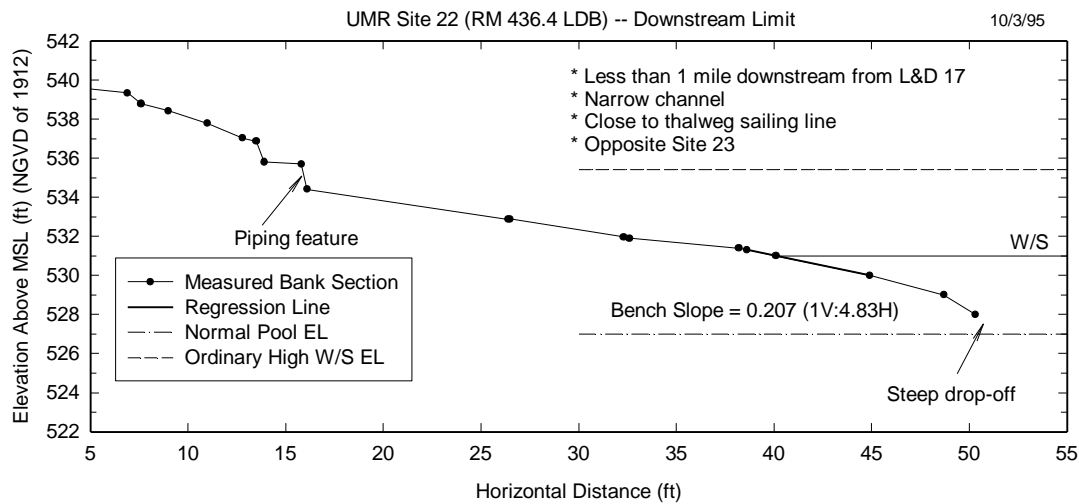
An upstream view of the midpoint section is shown in Photo 7-54. Five bank sections were taken at the erosion site: at the upstream limit; the upstream quarter point; the midpoint; the downstream quarter point; and the downstream point. The sections are depicted in figures 7-82 through 7-86. As can be seen in figure 7-84, the channel cross

section is a typical parabolic shape common to straight channels. The bank soils consist of silt (FST-MST) with moderate piping features and subaqueous sediments are silt (MST-CST) and sand (VFS). Site 22 is very close to the thalweg sailing line. Steep subaqueous bank slopes observed along the bank downstream from the midpoint section indicate that this reach is subject to strong currents and vessel-induced prop-wash.

Causative factors for bank retreat at this site include flood-flow erosion and slumping during the rapid recession period, wave and flow rework-transport of failed soils and recently deposited sediments, and moderate piping failures. Because of the closeness to the thalweg sailing line, potential exists for wave erosion of failed soils and recently deposited sediments. Type C characterizes Site 22.

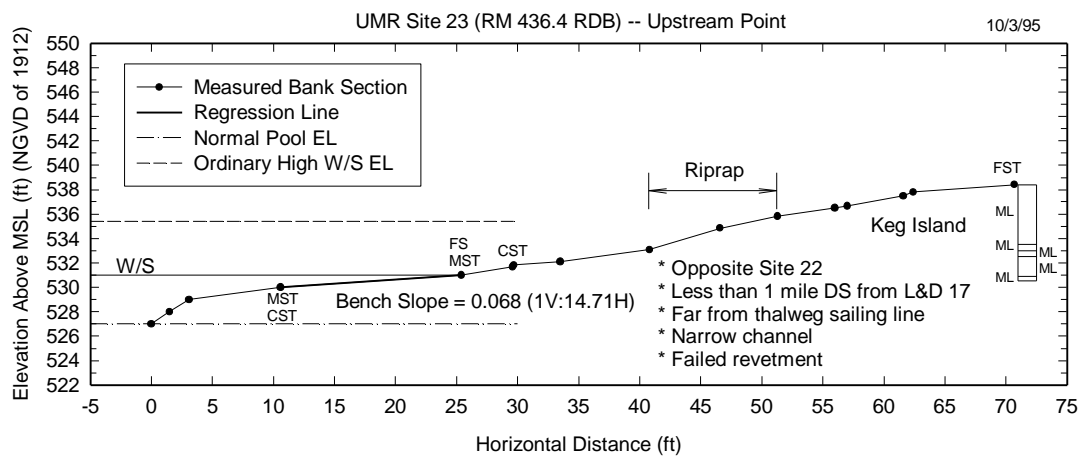
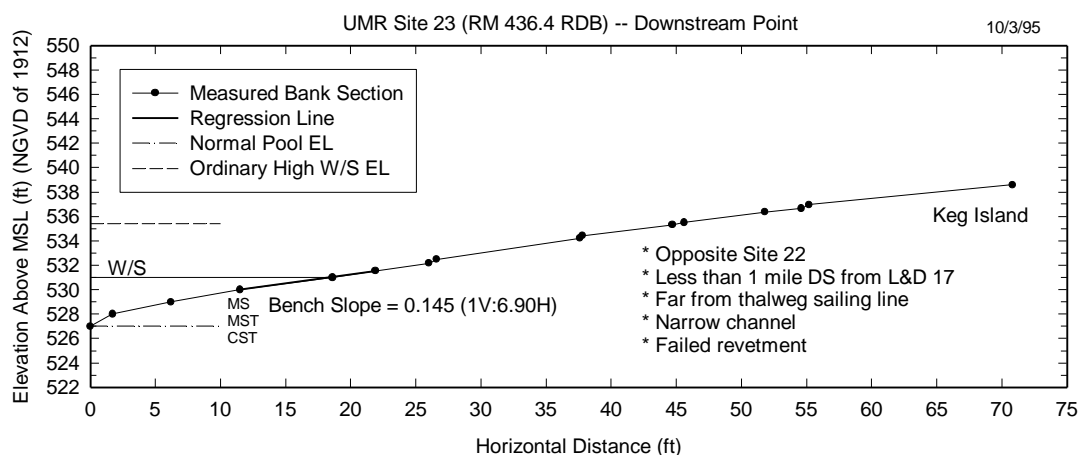
This right-bank site is located on the upper portion of Keg Island across the channel from Site 22 (see figure 7-81). A downstream view of the upstream site is shown in Photo 7-55. Two bank sections were taken at upstream and downstream points, and they are shown in figures 7-87 and 7-88. No midpoint section was established. The site is located far from the thalweg sailing line. As can be seen in figure 7-87 and Photo 7-55, stone slope-protection failure was observed at the upstream section. The bank soils consist of lensing silt (FST-CST) and some sand (FS) was found on the surface along the water's edge. Subaqueous sediments are silt (MST-CST) at the upstream section, and are silt (MST-CST) and sand (MS) at the downstream section.

Causative factors for bank retreat at this site include flood-flow erosion and recessional piping failures, and wave and flow rework-transport of bench-area failed soils and recently deposited sediments. Site 23 is classified as bank Type C.

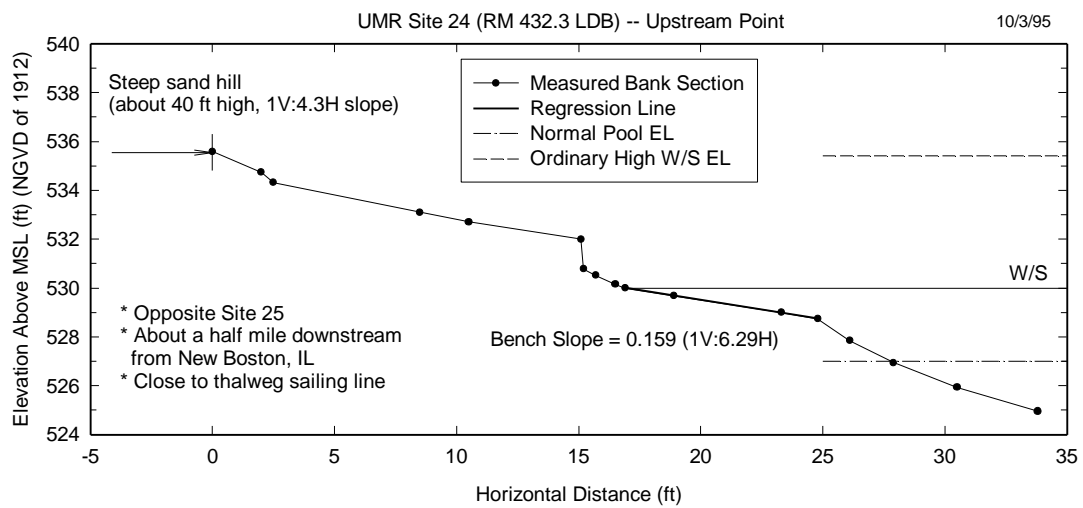
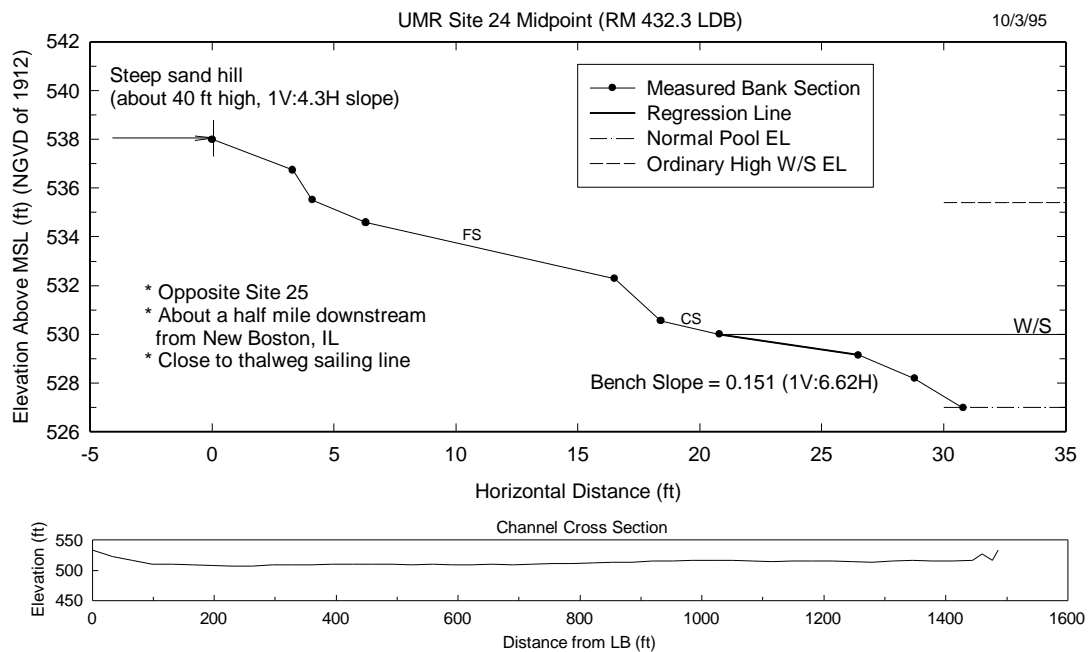
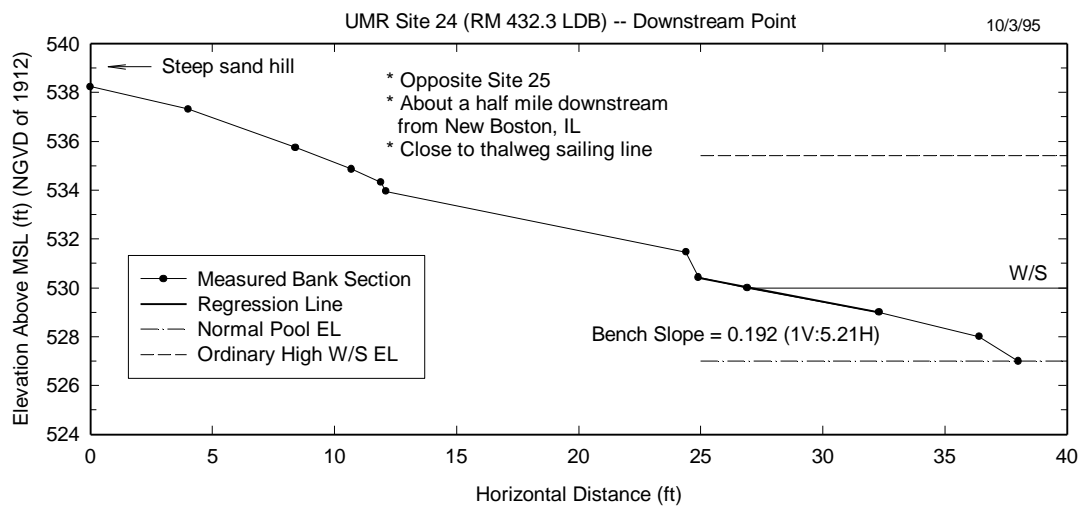
This left-bank site, shown in figure 7-89, is located along the outside of the downstream extent of a sharp bend, only 1.7 miles downstream from the mouth of the Iowa River (RM 434). The site is 4.8 miles downstream from Lock & Dam No. 17, and is close to the thalweg sailing line. An upstream view of this site is shown in Photo 7-56. Three bank sections taken at this site are shown in figures 7-90 through 92. The bank soils consist of sand (FS-CS), and a steep sandy slope rises approximately 40 ft above the berm. This feature is shown in the bank sections.

Causative processes for bank retreat at this site include flood erosion and recessional failures, and wave and flow rework-transport of bench-area failed soils and recently deposited sediments. Because the bank soils are primarily fine sand, wave erosion is extensive. This site is characterized by bank Type F.

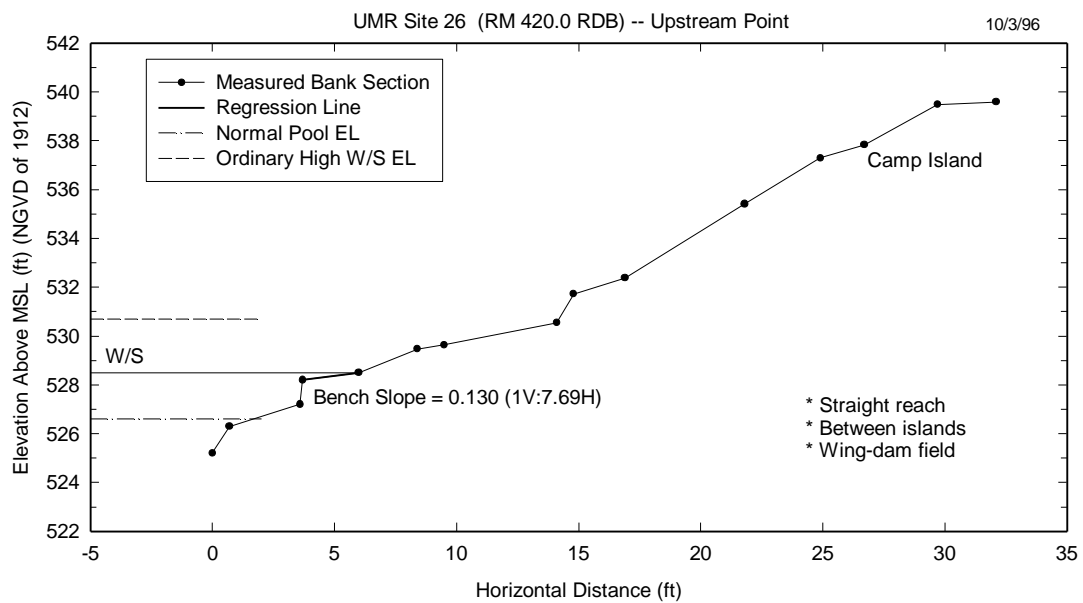
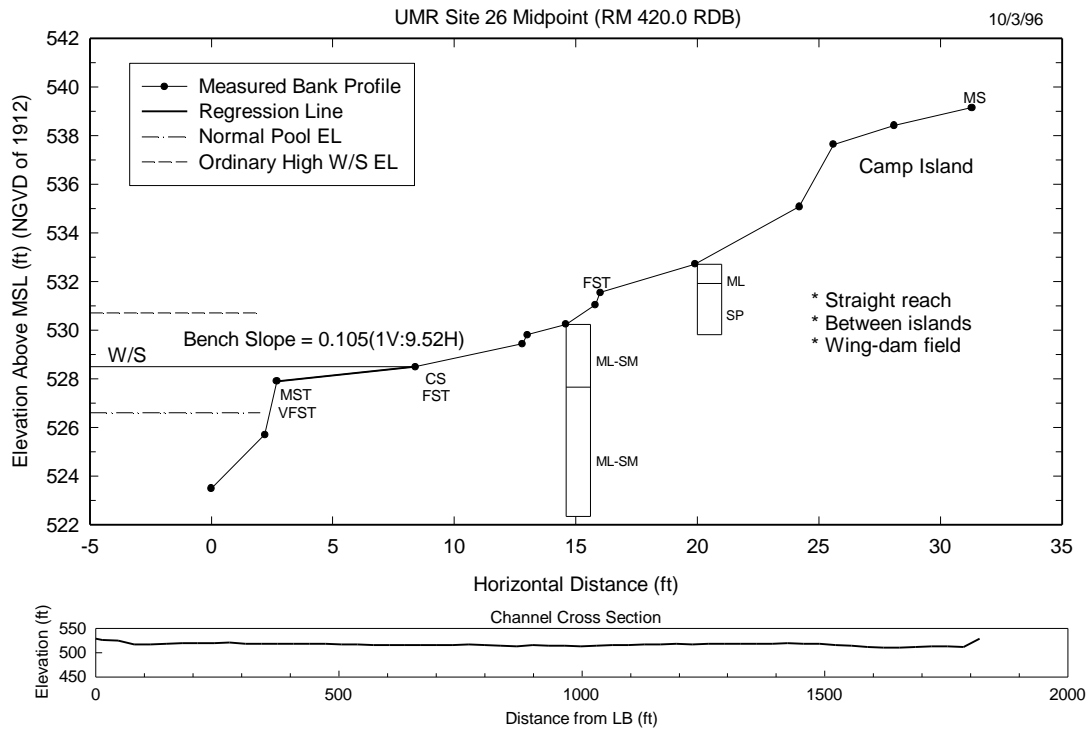
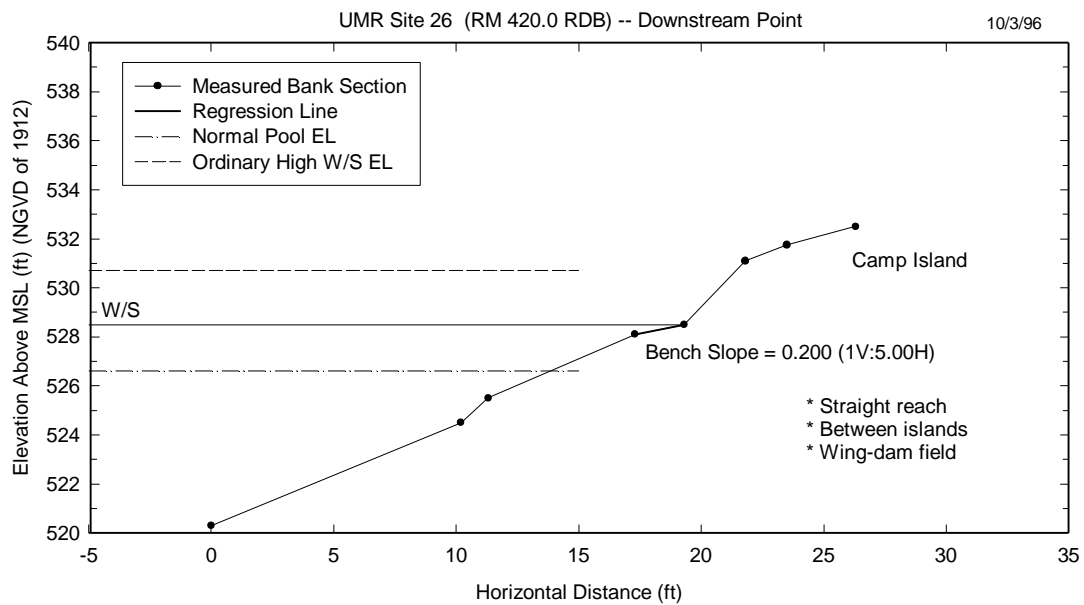
This right-bank site, shown in figure 7-94, is located on Camp Island along a straight channel reach. The site is about 9.5 miles upstream from Lock & Dam No. 18. Camp Island is one of numerous islands formed downstream from the confluence of the Mississippi River and the Iowa River. An upstream view of this site is shown in Photo 7-58. Three bank sections taken at this site are shown in figures 7-95 through 7-97. The bank soils are mainly silt (FST) and sand (MS-CS), and subaqueous bench soil is silt (VFST-MST). As can be seen in the river cross section (figure 7-96), the thalweg is developing along this island. Severe in-channel erosional bank oversteepening is indicated by the steep subaqueous bank slope.

Causative factors for bank retreat at this site include flood-flow erosion and recessional slumping of oversteepened banks and piping-related collapse with seepage, and wave erosion within bench areas affecting rework-transport of failed bank soils and recently deposited sediments. Because of the closeness to the thalweg and silty bank soils, wave erosion is more extensive at this site. A combination of bank Type E and Type F characterizes this site.

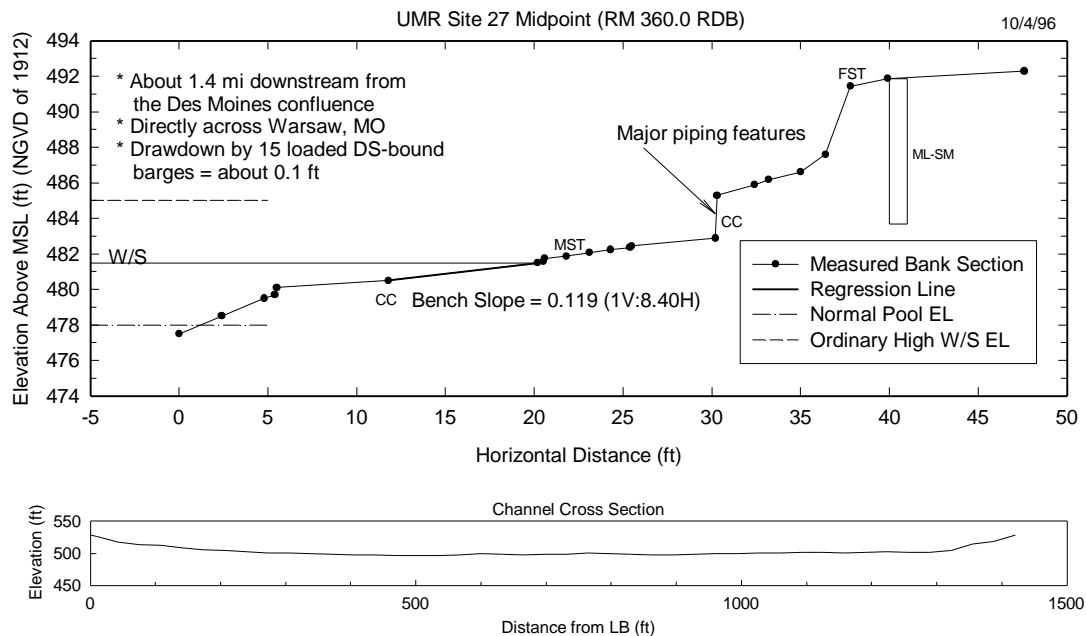
Figure 7-99 Bank section and channel cross section measured at Site 27 midpoint

Causative factors for bank retreat at this site include flood-flow erosion and recession and piping-initiated slumping, slaking, seepage, and wave and flow rework-transport of failed and slaked bank soils and recently deposited sediments within bench areas. Site 27 is classified as Type A.
